8.0 Errata Sheet

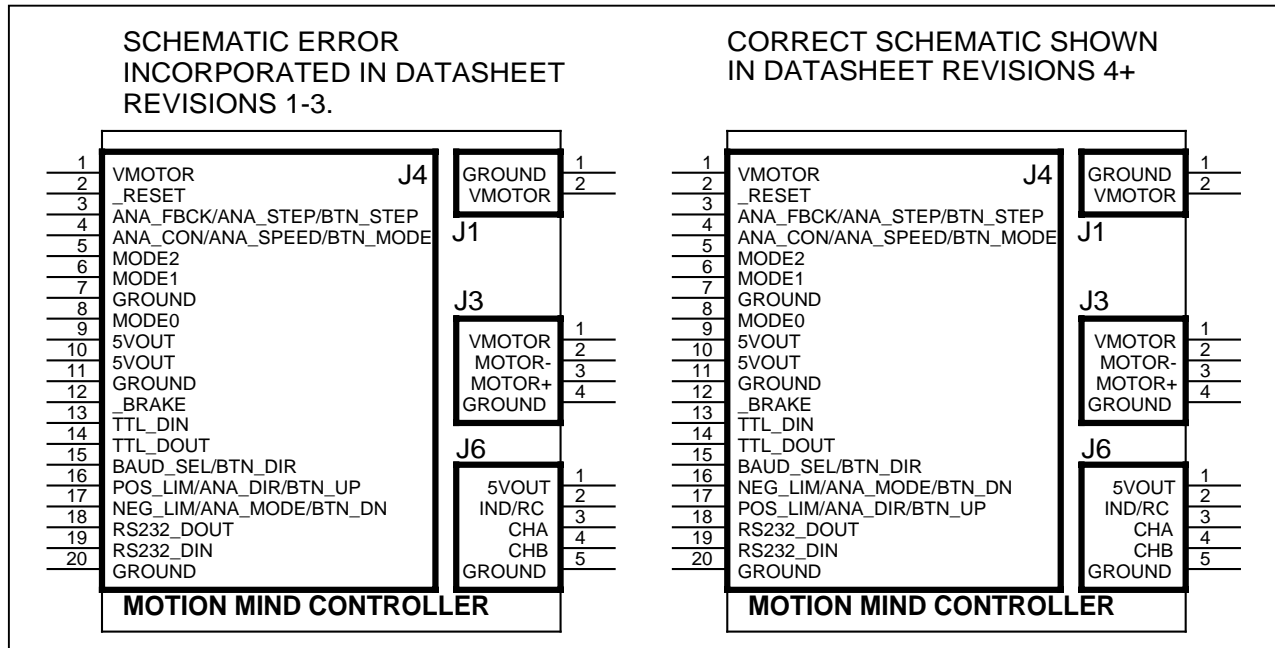
Datasheet Error: Datasheet revisions 1-3. The pin functions for J4 P16 and J4 P17 were swapped on earlier datasheet revisions. J4 P17 is the positive limit switch, analog direction, and button up input, J4 P16 is the negative limit switch, analog mode, and button down input.
